Fawn River Restoration

STREAM RESTORATION

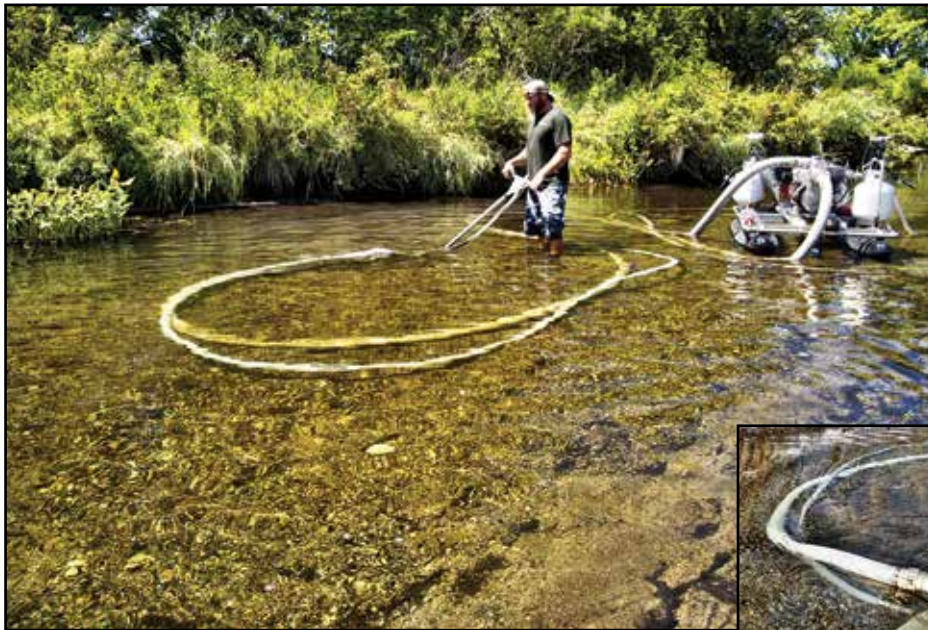
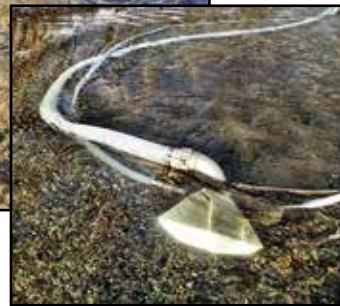
The removal of sediment in a strategically narrowed area deepens and accelerates flows through the cleaned thalweg. Inset: The Sand Wand™ is a manually operated and selectively removes the non-native silts & fine sand material.

contractors were all charged with regularly walking the river to evaluate the integrity of the restored areas. The new approach has proven to be optimal. The removal of sediments in a strategically narrowed area deepens and accelerates flows through the cleaned thalweg, and conversely slackens flows over the deposits left undisturbed and where the river was already attempting to redevelop bank. The result is a beautifully restored gravel bottomed river.

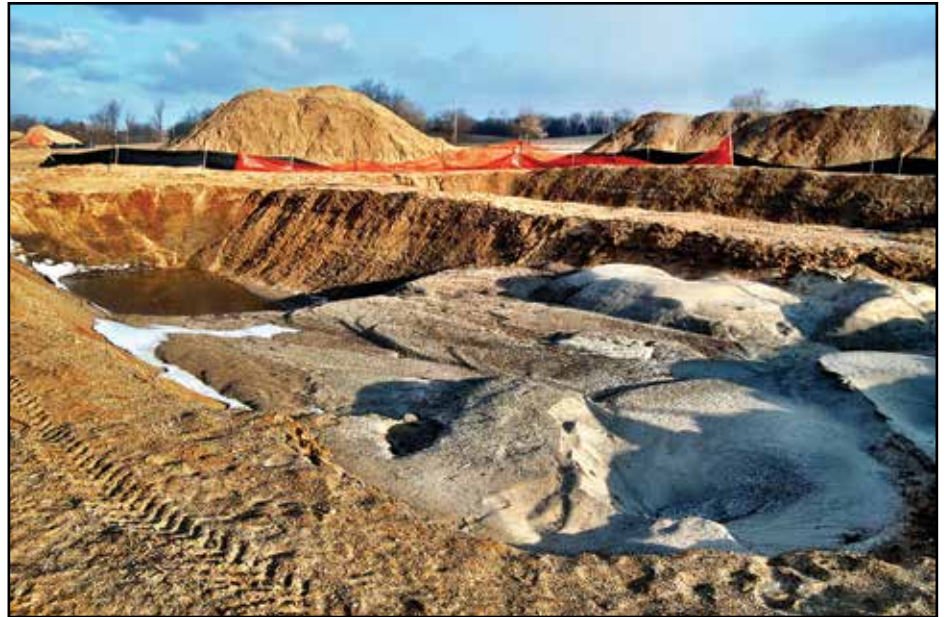
The material removed using the Sand Wand™ is pumped to discharge or dewatering pits. These pits are temporary and excavated in upland areas.

Initial operational choices were also dictated by the decision not to use heavy equipment in the river, and riparian corridor. This led to selection of the low impact, man operated, Sand Wand™ technology from Streamside Environmental, LLC, (“Streamside”). The Sand Wand™ selectively jets and suctions out of the hyporheos only the fine materials, leaving gravel and cobble in place. The removed sediments are pumped as slurry to dewatering pits located on former agricultural fields.

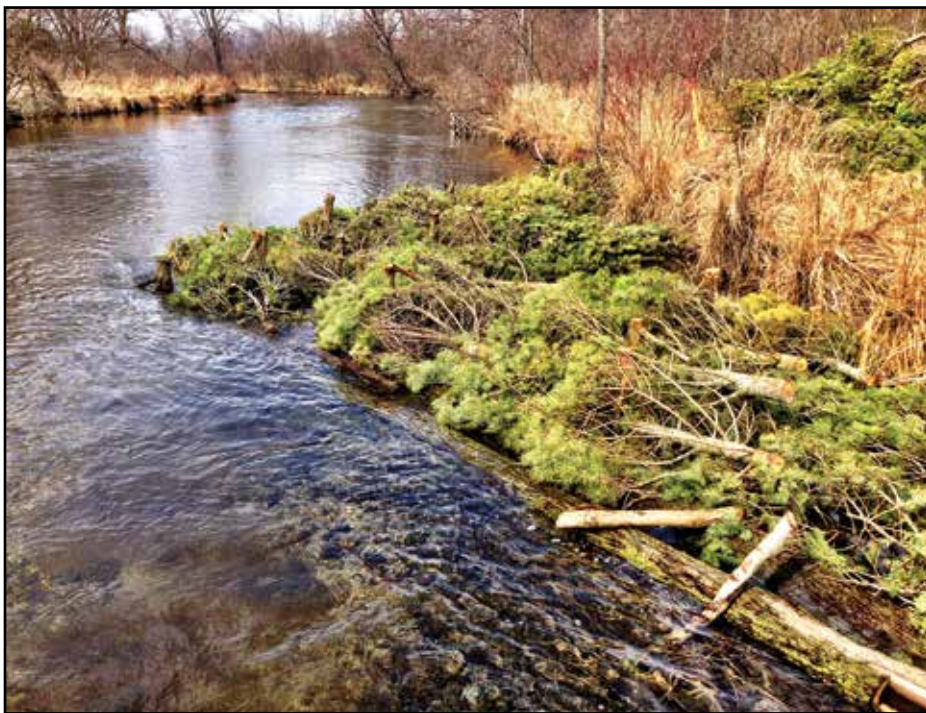
LWD structures are strategically placed in coordination with the sediment deposits left in place to help stabilize depositional areas.

The Trust chose Kanouse Outdoor Restoration (“Kanouse”) based on the company’s prior experience in observational based stream restoration and adaptive management. Kanouse mobilized a crew 2 days after the final regulatory approval, and rapidly worked to install the most critical LWD structures ahead of high spring waters. The structures are strategically designed to enhance the focus of flows through the restored thalweg, prevent

erosion of the sediments selectively left in place, and simultaneously capture and incorporate excess sediments into those areas already rebuilding bank. As water levels drop this summer, rebuilding bank will be further stabilized with plantings of native vegetation.
